# GENERATIONS HOME INSPECTIONS LLC

## RESIDENTIAL REPORT

12356 Kendall Rd  
Orange, VA 22960

NOVEMBER 13, 2024

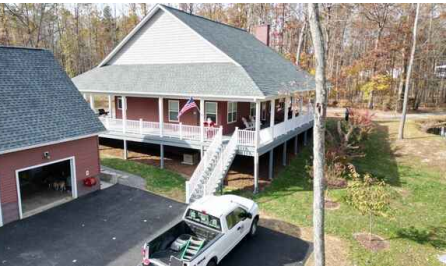
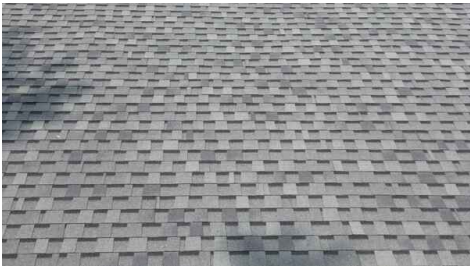
It was observed on the day of the inspection the the home had dimensional asphalt shingles.

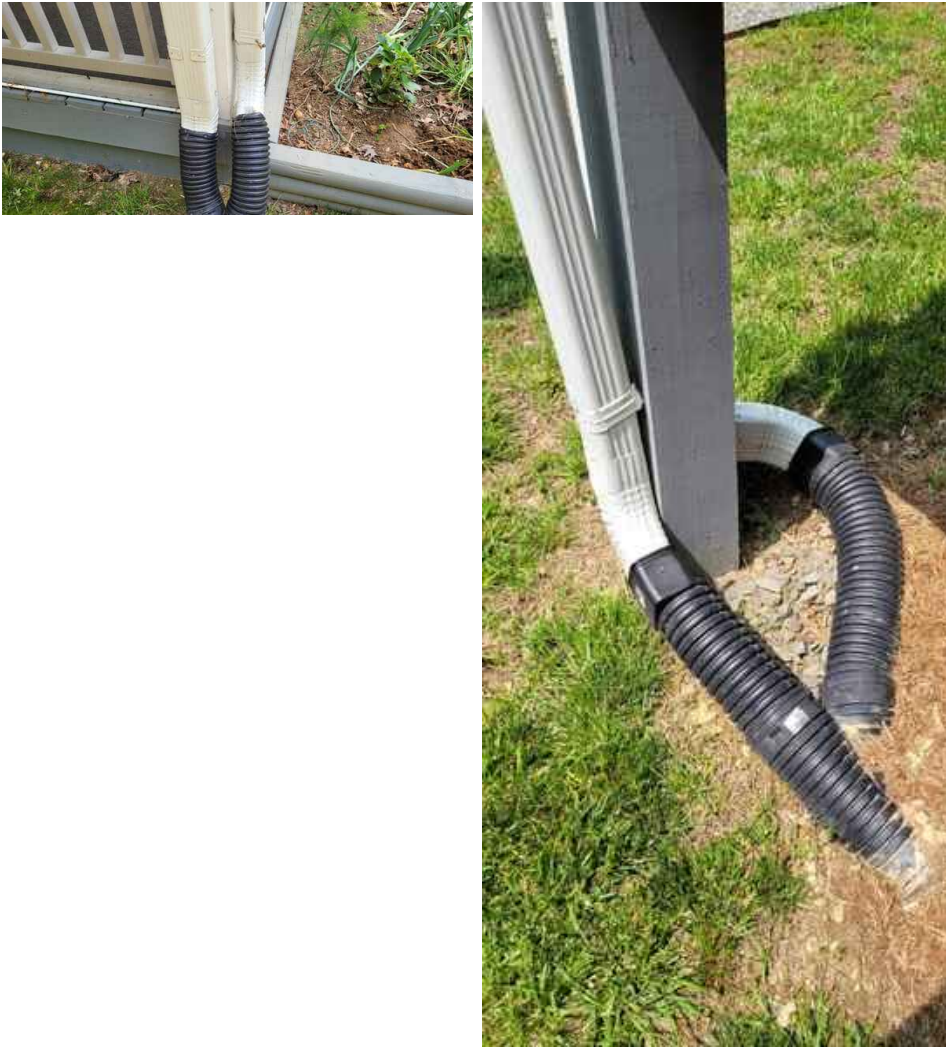
All Drain pipes that were visible were observed to be in good condition on the day of the inspection.

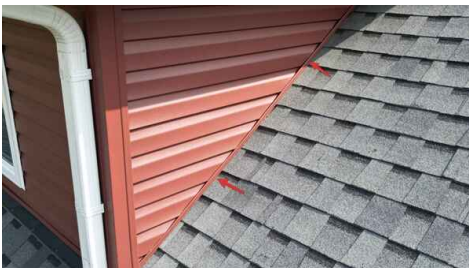
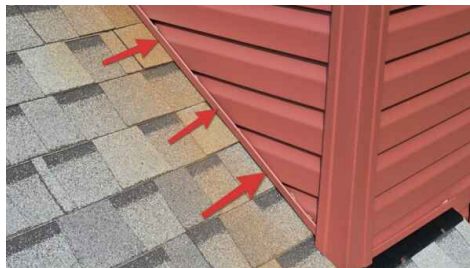
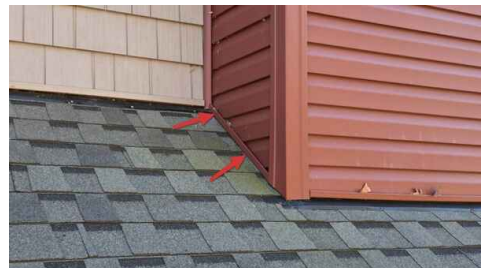
VARIOUS AREAS WHERE SIDING IS COVERING FLASHINGS

Any unseen flashings and portions of flashings that are covered by building materials are excluded from this report. Any leaks originating from unseen flashings are excluded from this inspection.

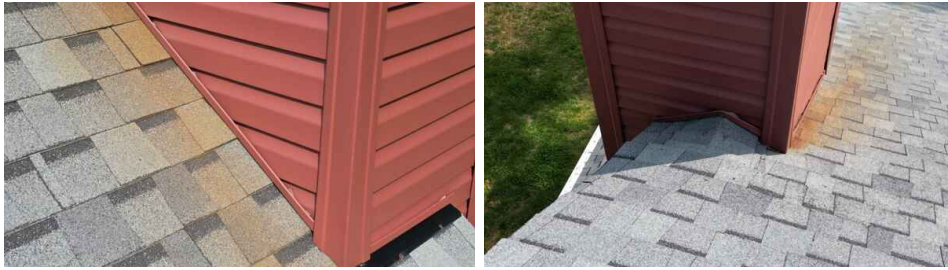
### 2.1.1 Coverings

#### ROOF STAINING

On the day of our inspection the roofing material near the chimney had staining we believe due to the metal chimney cap rusting and spilling over onto the roof surface before it was painted. It is recommended that the chimney cap should be monitored in the future for possible rust.

This condition is repeated in detail later in this report .

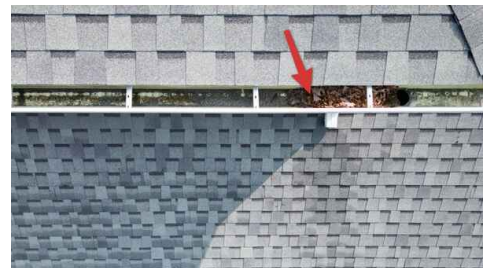
Debris has accumulated in the gutters. Recommend cleaning to facilitate water flow.

Recommendation

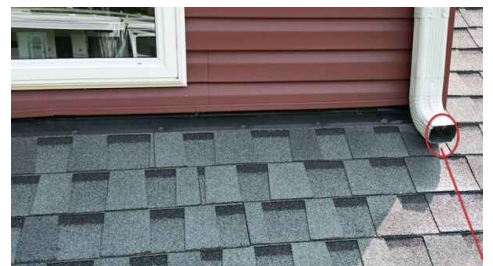
On the day of the inspection it was observed that the downspouts (2) from the second floor roof was draining directly onto the first floor roof surface. The excessive water concentration of water in one location can cause the asphalt shingles to wear much faster than normal.

If in the situation as this there is no other gutter to drain it into we would recommend a diffuser be installed to slow the moving water as much as practicable.

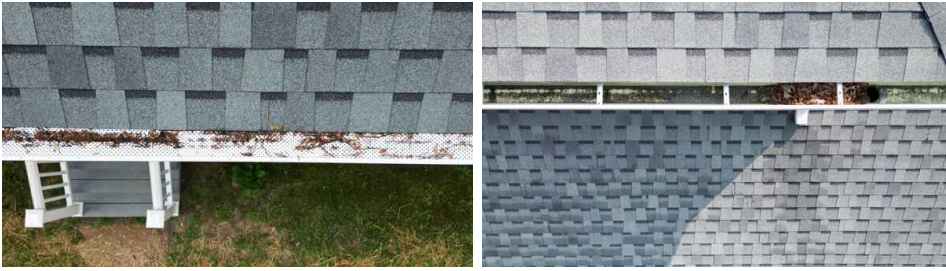
On the day of our inspection it was observed that the first floor gutters had guards installed ,the second floor did not . This is not a deficiency, just an observation.

We would recommend that Guards also be added to the second floor gutters due to the fact that they are getting filled with debris and they are difficult to get to for observing or cleaning.

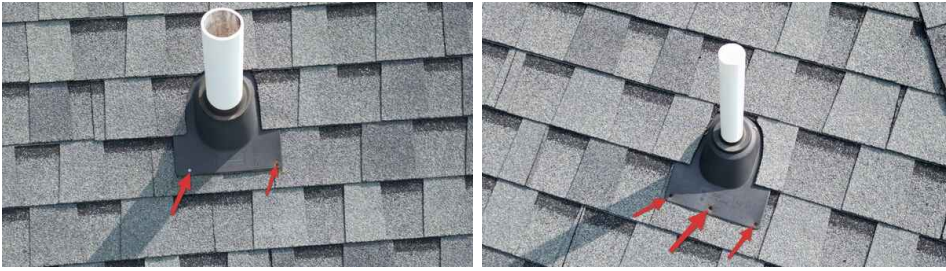
On the day of the inspection It was observed that the plumbing vent pipe flashings on the rear of the home Had face nailing on them which is sometimes typical for the application but it is recommended that the face nails have sealant applied to the nail heads to keep them from rusting away causing a potential roof leak.

Silicone is not the recommended sealant to use, I recommend using a urethane based roof sealant for this application.

Contact a qualified professional.

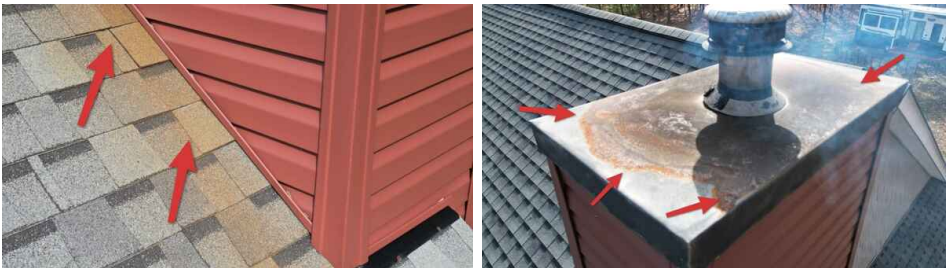
On the day of the Inspection it was observed that the Chimney cap flashing had been rusting causing staining on the roof below it . It is recommended that this condition be **monitored** for future rusting having it coated properly as to prevent any future rusting and or staining.

It was also observed that the metal chimney cap had been holding water/ ponding .We recommend fabricating the cap in away that would shed the water rather than it ponding causing it to rust much faster.

Contact a qualified professional.

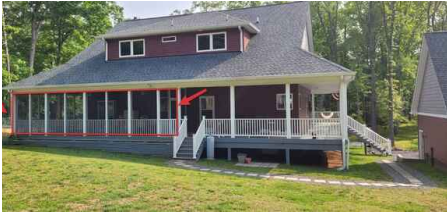
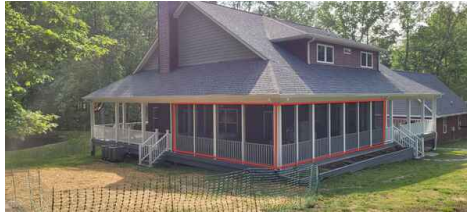
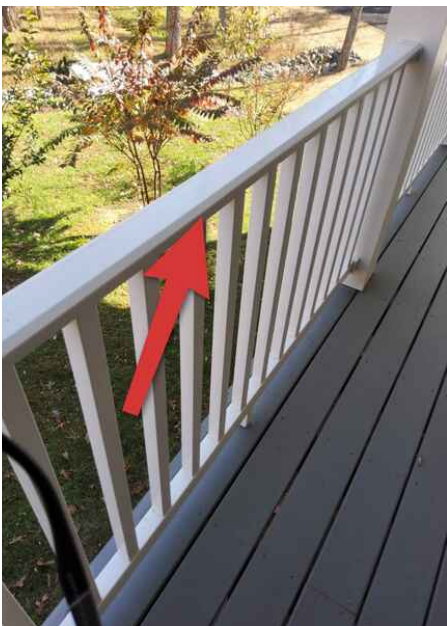
**Decks, Balconies, Porches & Steps: Porch, Decking, and railing Material**

Wrap around deck with screened room in the rear

Stained Pressure treated Decking.

Vinyl Railings.

nylon screened in room.

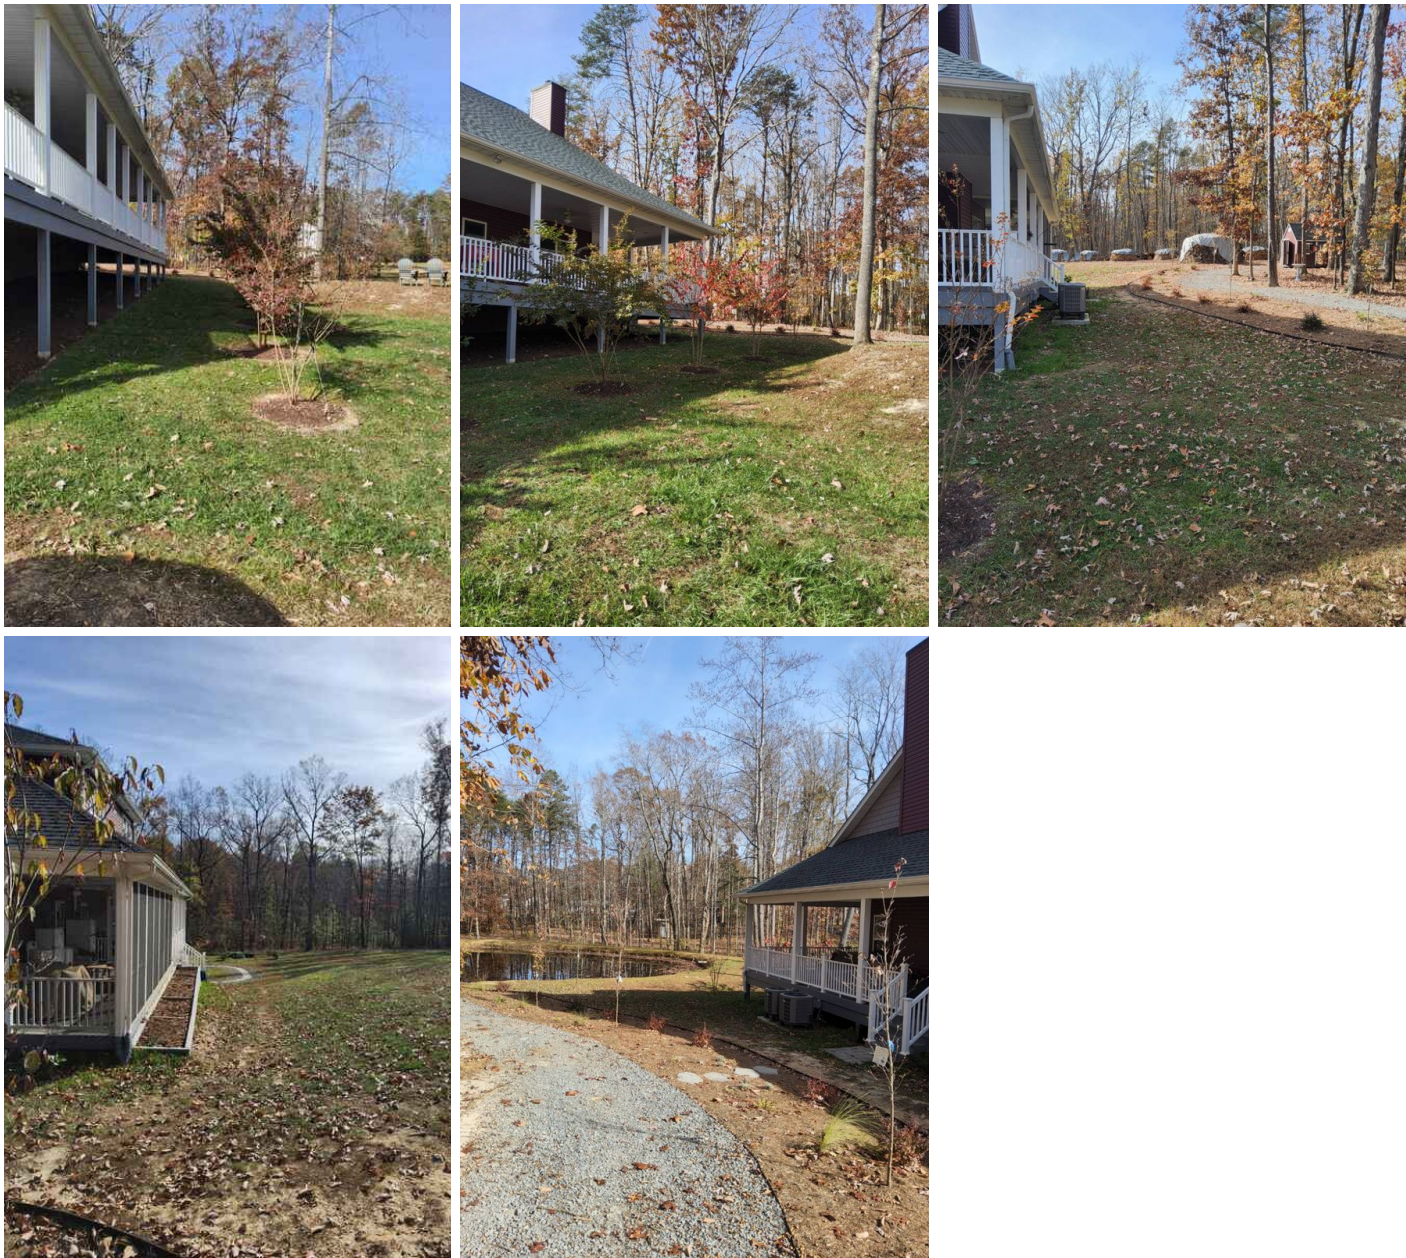
**Vegetation, Grading, Drainage & Retaining Walls: Photos of exterior grade close to home**

All sides of the home

Grade overview

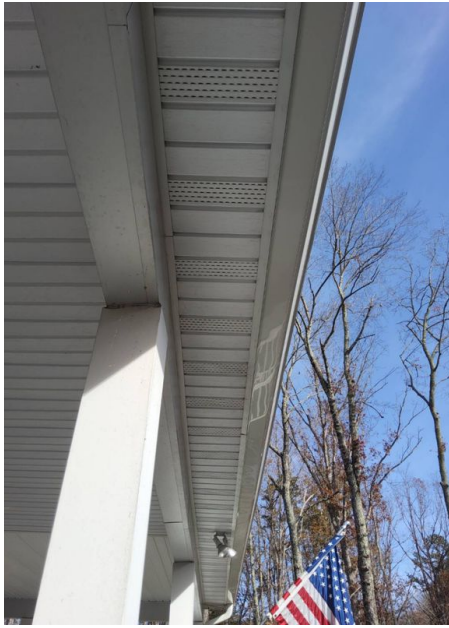
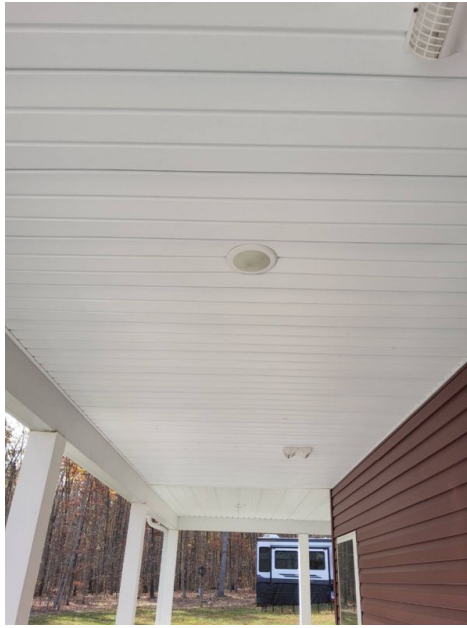
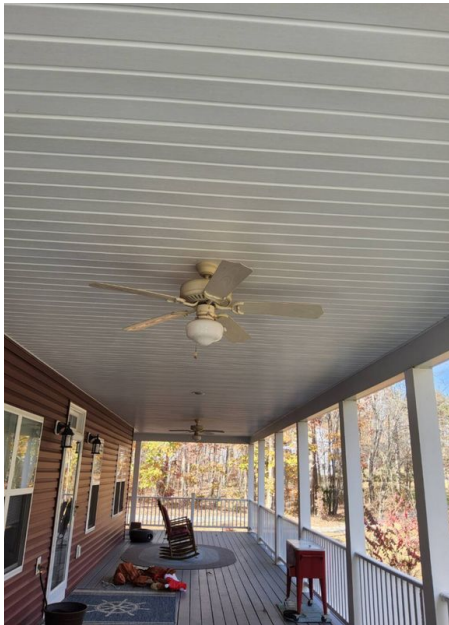
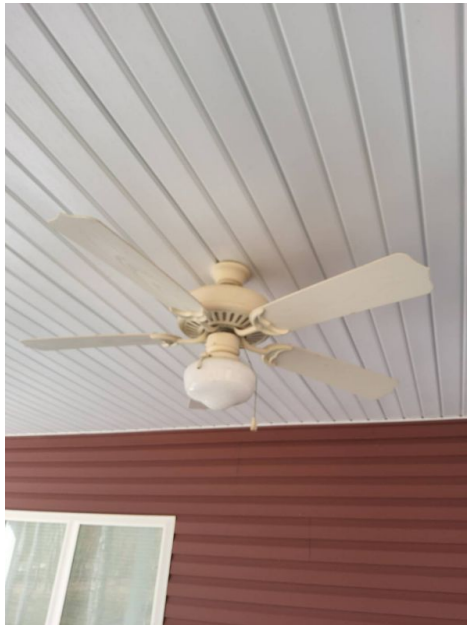
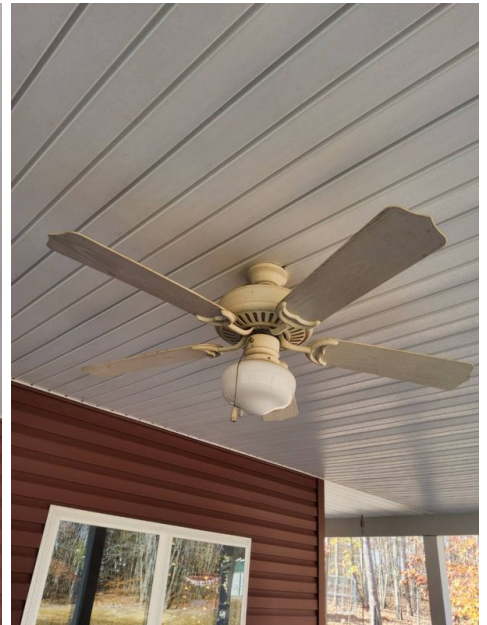
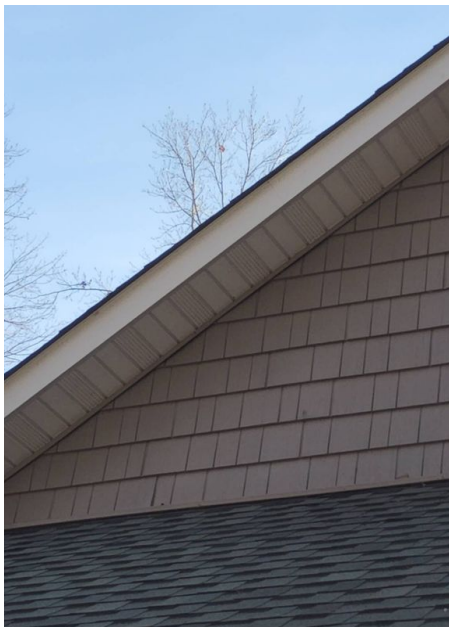
**Eaves, Soffits & Fascia: Eaves and soffits**

On the day of the inspection there were no deficiencies noted with the soffits, eave's and facias.

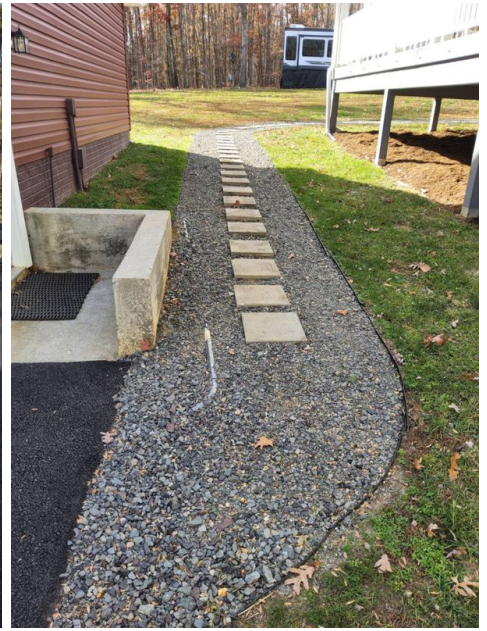
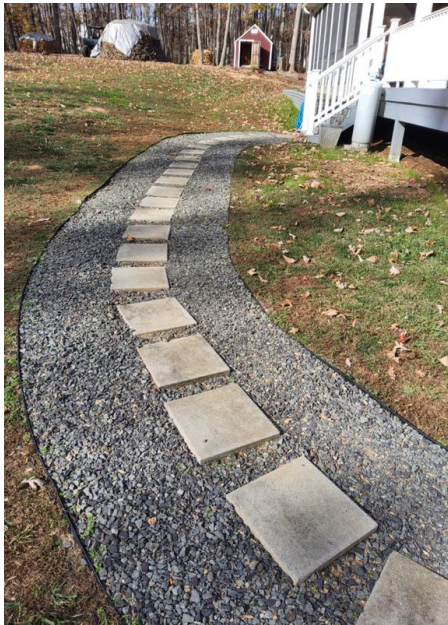
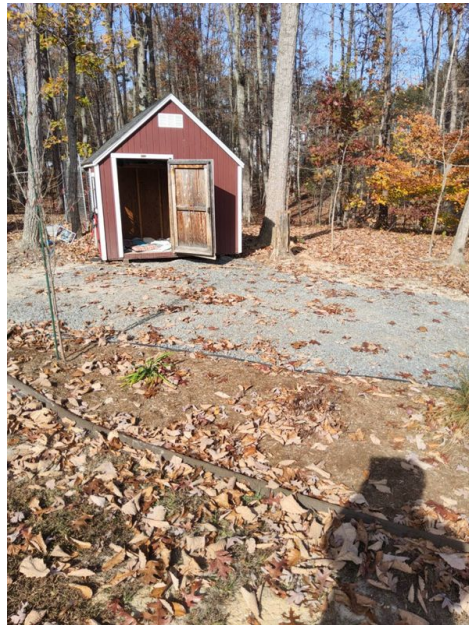
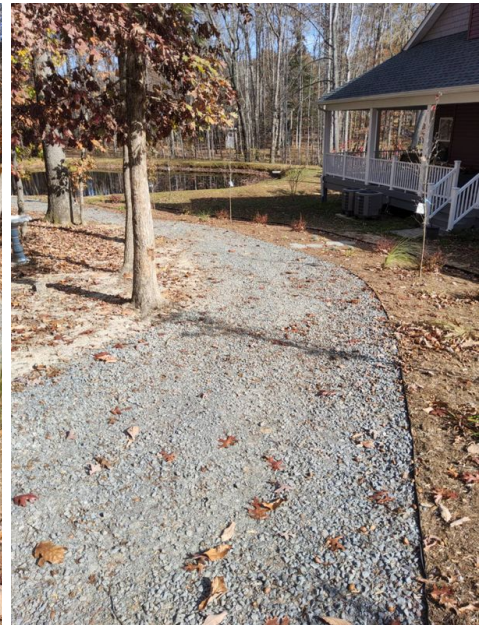
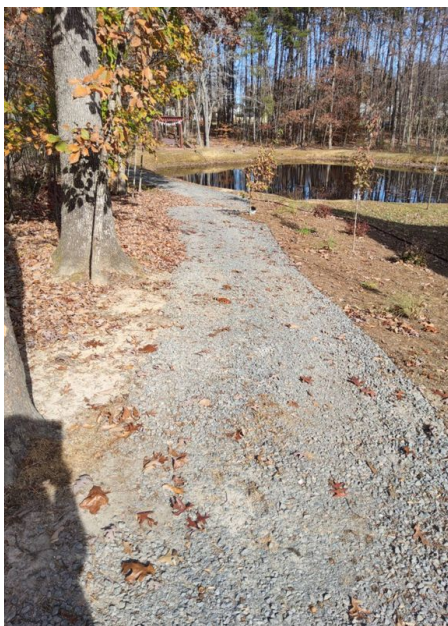
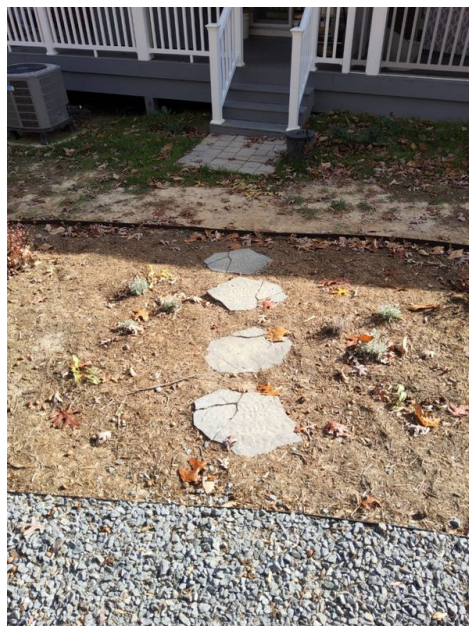
**Walkways, Patios & Driveways: Driveway Material**

Asphalt, Gravel, Pavers

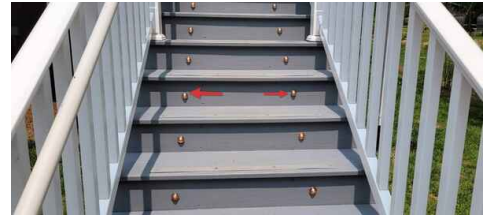
On the day of our inspection it was observed that someone has installed low voltage lighting at the front of the home in the risers of the set of stairs to the front door from the driveway.

These lights are outside the SOP and are excluded from this inspection.

It was confirmed by the homeowner that they do work, they were currently on a dusk to daylight timer of which we were asked not to tamper with.

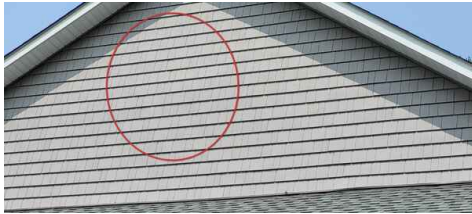
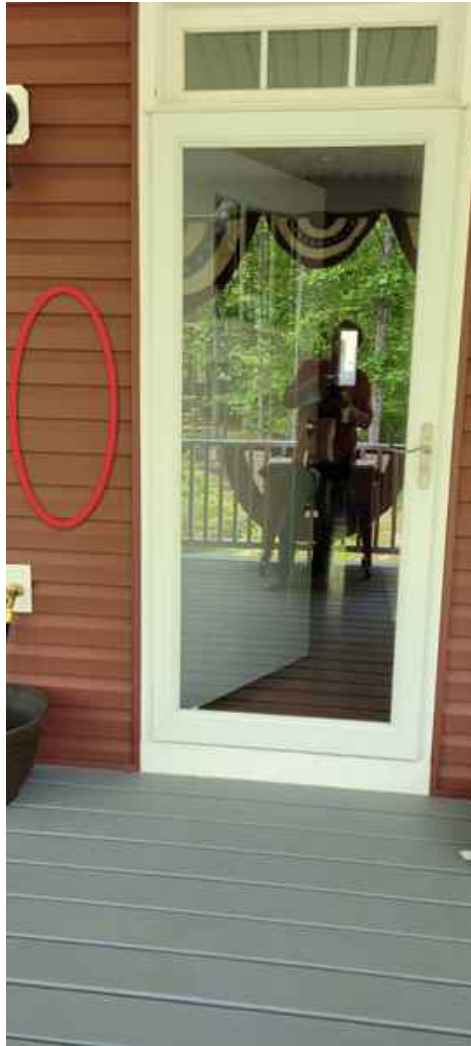
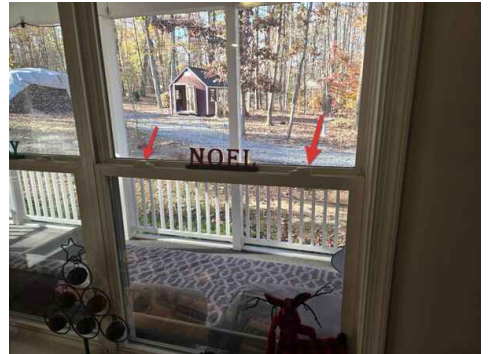
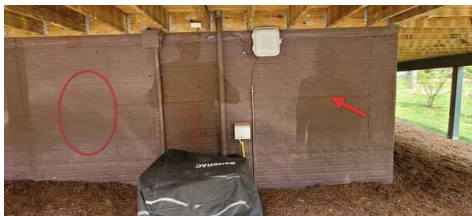
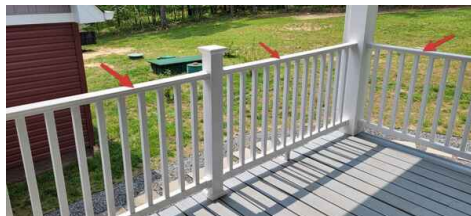
3.2.1 Siding, Flashing & Trim

Gable ends and House walls are of Vinyl Material. Recommend that it all be monitored for possible staining in the future. If staining occurs It can be power washed by a qualified professional .

All Railings were observed to be of Vinyl / composite.

All Decking is a stained pressure treated wood, Recommend cleaning as needed.

Foundation Walls were observed to be poured concrete with a painted finish. It is recommended they be monitored for the need of repainting in the future.

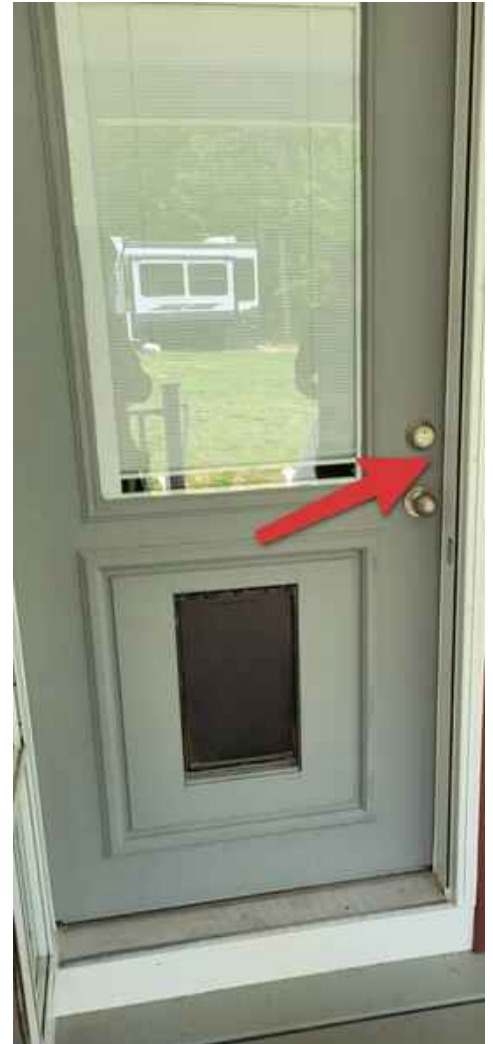
Door does not close or latch properly. Recommend qualified contractor evaluate and make corrections.

This can be a safety hazard/ security issue to the occupants.

FYI , Large dog doors in your exterior egress doors to the home can also be a safety issue to the occupants in the home due to the fact that a man can slip through the opening even when the door is locked. It is recommended that some type of locking devise be incorporated that will keep intruders from entering the home .

Contact a qualified professional.

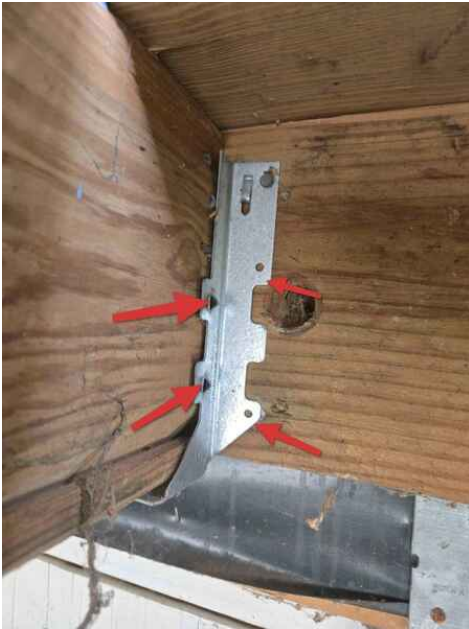
### 3.4.1 Decks, Balconies, Porches & Steps

#### **IMPROPER DECK CONSTRUCTION PRACTICES**

Deck was observed to have various joist hangers that did not have all their nails installed. Recommend qualified deck contractor evaluate and make corrections.

It is recommended that all hangers be inspected for missing fasteners. Proper fasteners must be used. They are called Teco Hangers and the Fasteners are called Teco Nails.

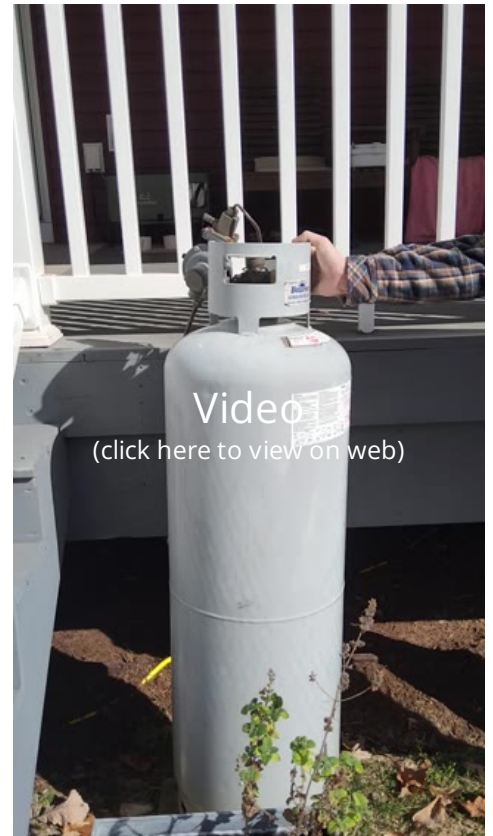
## 3.4.3 Decks, Balconies, Porches &amp; Steps

**UNSTABLE PROPANE TANK**

Observed on the day of our inspection, There was a smaller propane tank sitting at the rear of the home being used for a gas grill, and a interior cook top in the kitchen.

This propane cylinder was not secured in any way. This is a safety hazard, the cylinder could very possibly be tipped over causing injuries or starting a fire.

It is recommended a qualified professional evaluate and make corrections. Secure the tank Properly.

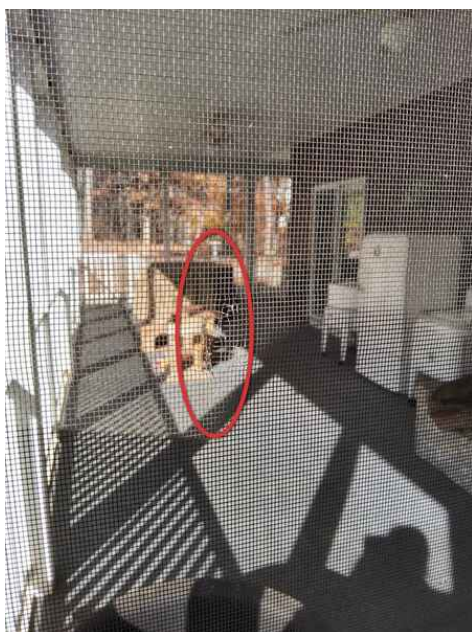
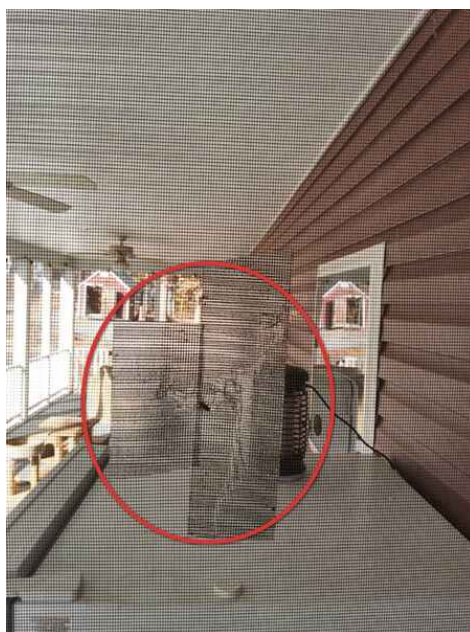
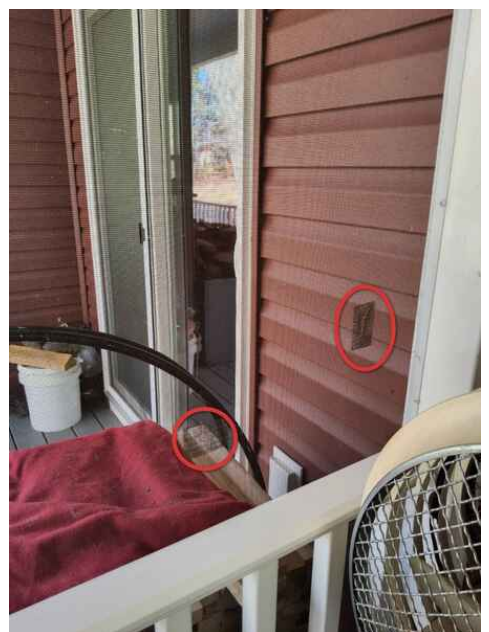
## 3.4.4 Decks, Balconies, Porches &amp; Steps

**SCREEN ROOM /DAMAGE SCREEN/REPAIRS**

On the day of the inspection it was observed that there was some light damage and repair work done to the screen surrounding the screened in room.

It is recommended that all the screened area be carefully examined for other damage, Behind any furniture etc. It will be up to the buyer/ sellers if it will be repaired or if the entire panel will be replaced.

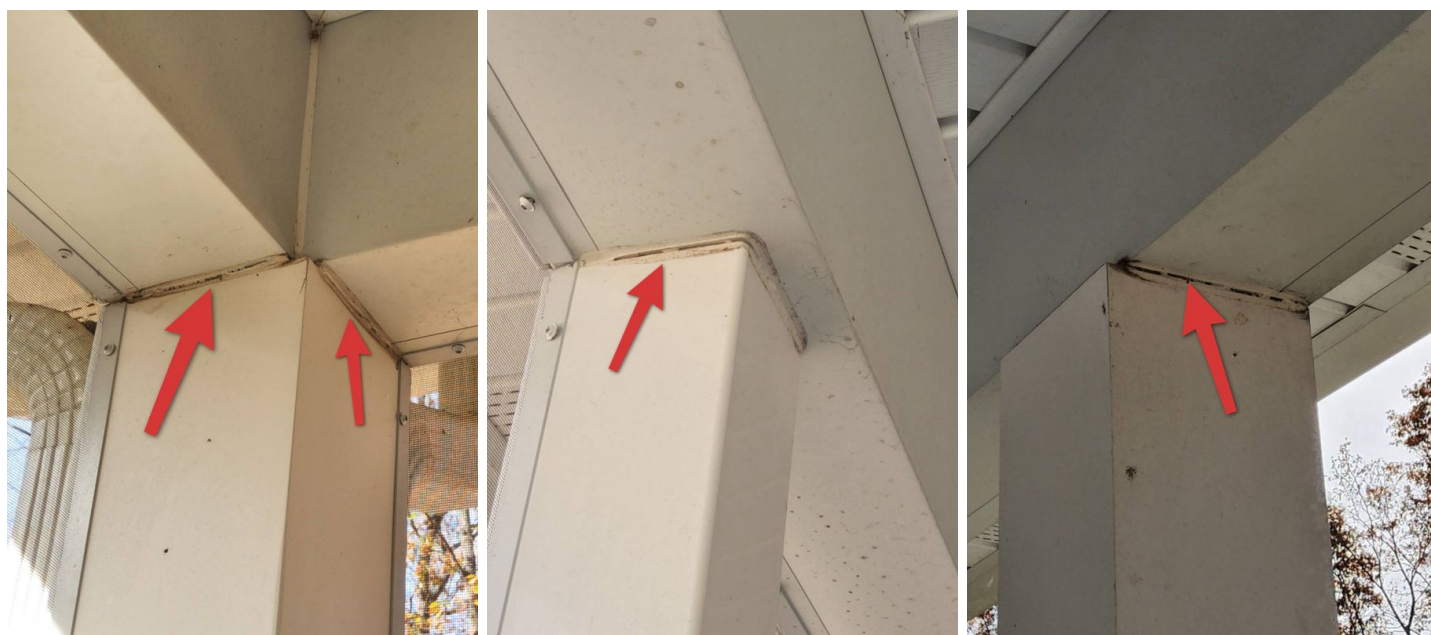
## 3.4.5 Decks, Balconies, Porches &amp; Steps

**CAULKING / SEALANT IN NEED OF UPGRADE/REPAIR**

On the day of the inspection it was noticed that there were multiple areas of sealant /caulking that needed to be repaired. This can lead to moisture and insect intrusion.

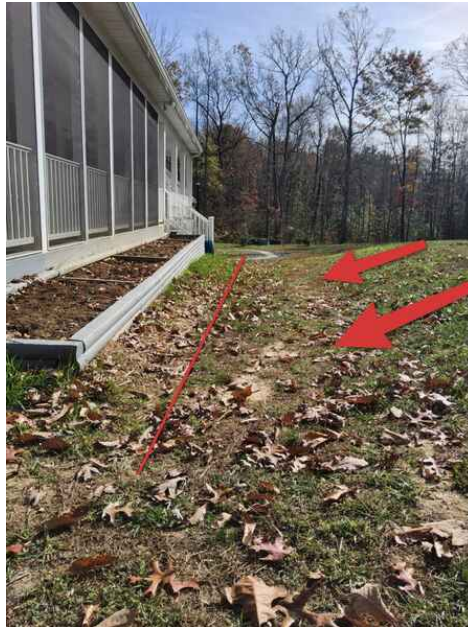
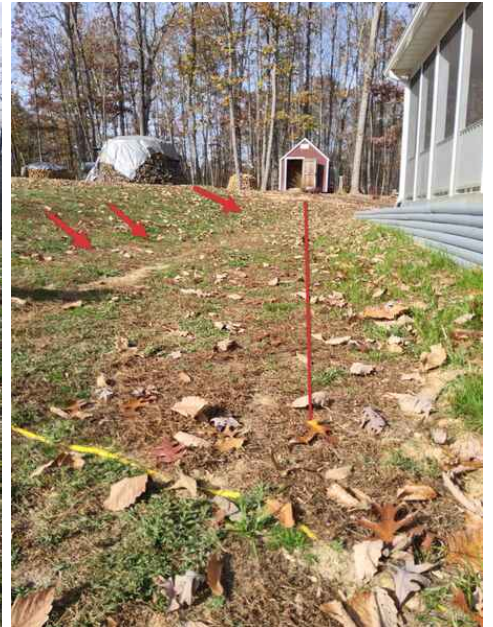
Grading is sloping towards the home in some areas. This could lead to water intrusion and foundation issues. It is recommended that a negative grade is maintained around the home with at least 6 inches of fall within the first ten feet from the home on all sides.

It is recommended that a more pronounced swale be formed along area dictated in the photo as needed.

Recommend monitoring.

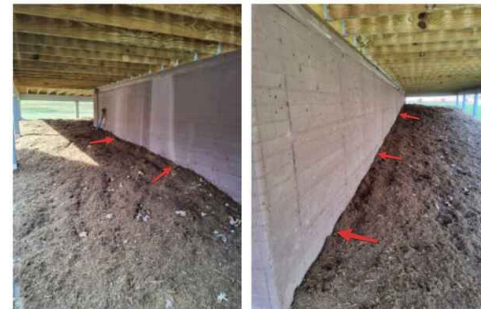
#### **MULCH AGAINST FOUNDATION**

It was observed on the day of the inspection that lots of mulch had been placed right up against the foundation which is conducive to attracting termites. It is recommended that the mulch be pulled back 6 inches from the foundation wall.

Contact a qualified professional.

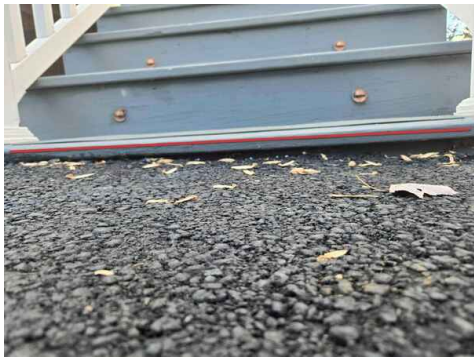
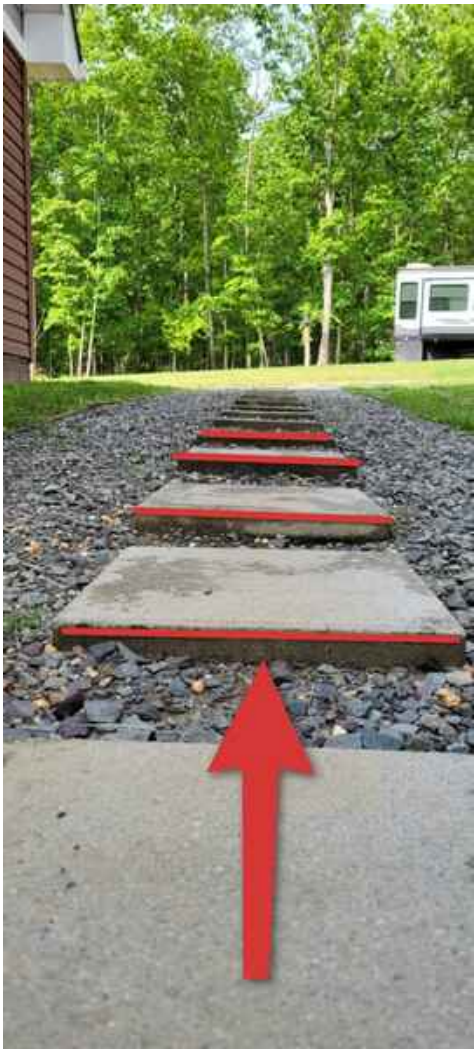
### 3.7.1 Walkways, Patios & Driveways

#### **WALKWAY TRIP HAZARD**

On the day of our inspection there was a walkway observed to have possible trip hazards. It is recommended that a qualified professional evaluate and make corrections.

On the day of our inspection there was a stepping stone walkway improperly laid producing multiple trip hazards. It is recommended that the stone be laid flat with the grade.

Also on the day of the inspection it was observed that when the asphalt driveway was installed at the main stairs to the home it has created a trip hazard at the first step. It is recommended that a transition be installed, when doing so it is important that there is no more than 1/4 in. thickness on the leading or trailing edge of the transition.

Contact a qualified professional.

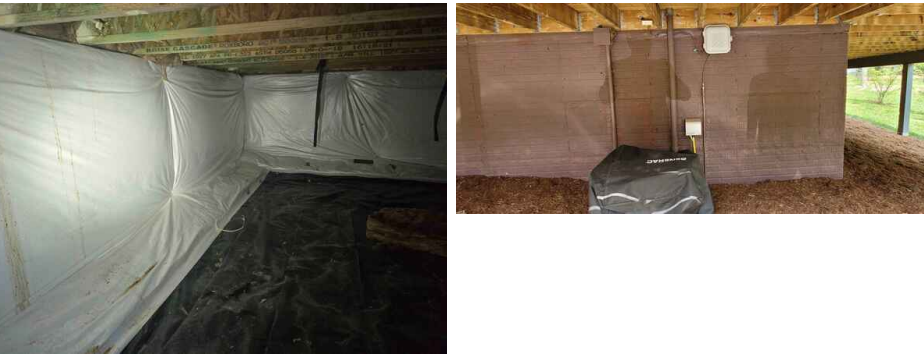
### Basements & Crawlspaces: Conditioned Crawl space

It was observed on the day of the inspection that the home has a conditioned crawl space.

Crawl space/ foundation is constructed of poured concrete, steel re-enforced with a brick pattern.

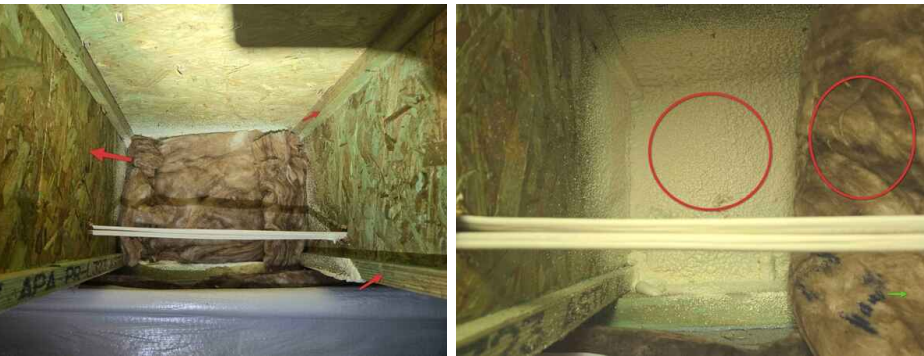
### Floor Structure: Various Framing components of floor system

Circles in picture pictures indicate spray foam insulation and fiberglass insulation pulled back to reveal spray foam insulation.

Arrows pointing to a TJI Floor joist.

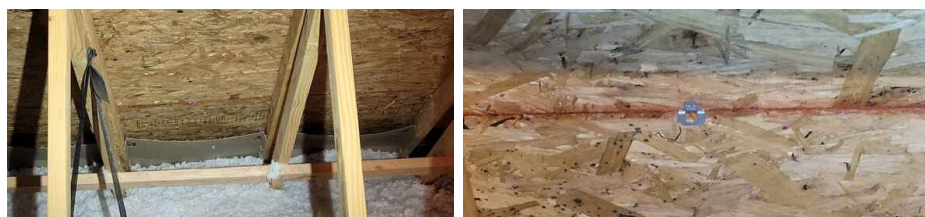
### Roof Structure

Pictures depict roof trusses and OSB roof sheathing and roof sheathing with required metal spacer/support clip.

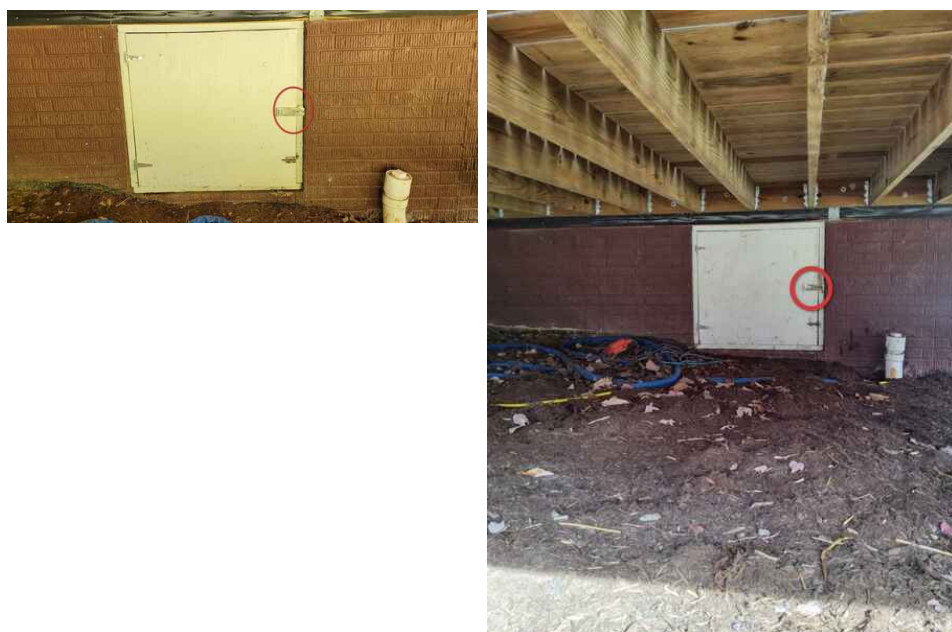
### Foundation/ Crawl space access

Crawl space access is at the rear of the home under the deck area.

Crawl space door has a hasp installed with a wooden wedge holding it closed. It is recommended that a child proof lock at minimum be installed on this door to the crawl space.

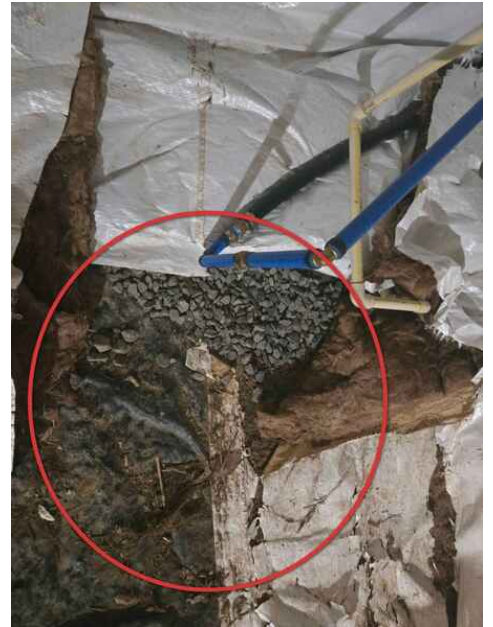
### 4.1.1 Basements & Crawlspaces

#### **CRAWL SPACE VAPOR BARRIER DAMAGED OR MISSING**

On the day of our inspection it was observed that the vapor barrier in the crawl space had one or more bad/ torn areas that need to be repaired .

Torn vapor barrier in a conditioned crawl will allow moisture to access the crawl space which could be conducive to mold growth. It is recommended that a qualified professional evaluate and make corrections.

Contact a qualified professional.

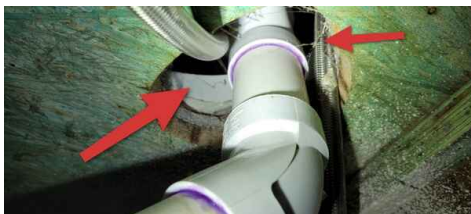
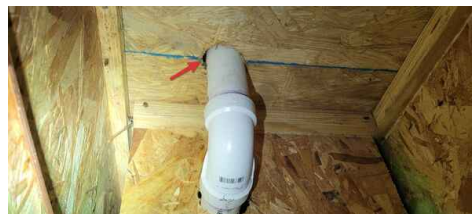
On the day of the inspection it was observed that one or more locations there where penetrations that had been made through the subfloor that were missing firestopping Material.

It is recommended a qualified professional evaluate and make corrections.

Contact a qualified professional.

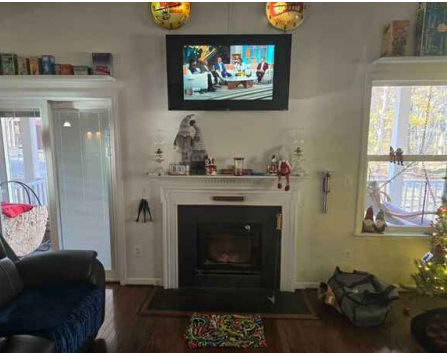
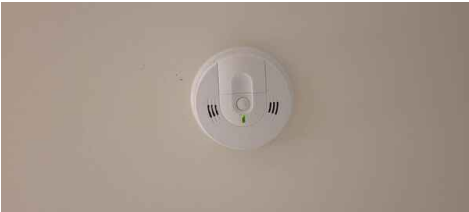
| <b>Wood burning Fireplace</b><br>Main Living area<br><br>Wood burning fireplace with slate surround and slate Hearth.<br>Smoke monoxide combo in place. | | |

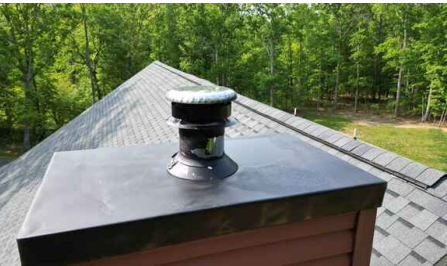
| <b>Vents, Flues &amp; Chimneys: Prefabricated Flu pipe</b><br>Roof Flu termination<br><br>Prefabricated dual wall flu pipe was observed to be installed on the day of the inspection. |

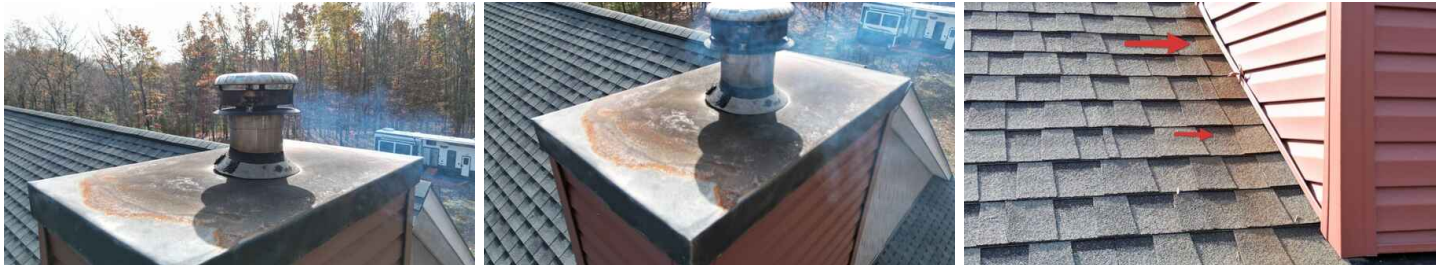
Metal chimney cap was observed to be rusting and staining roof. It is recommend a chimney specialist evaluate and make corrections.

This condition has caused roof staining that is not damaged at the present time/ only a cosmetic condition.

It is also recommended that the chimney cap be fabricated in a way so water will not stand/ pond on the cap causing it to rust at a rapid rate. Allowing it to dry quickly.

Contact a qualified professional.

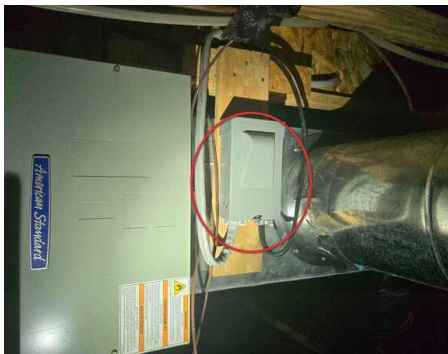
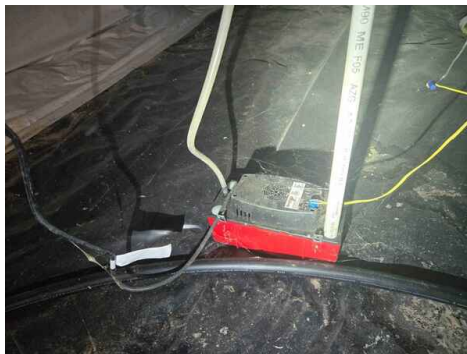
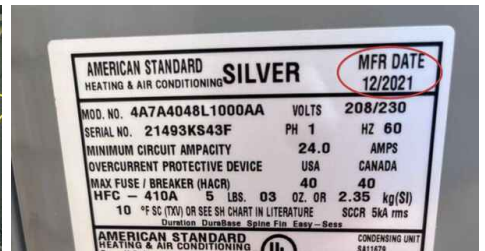
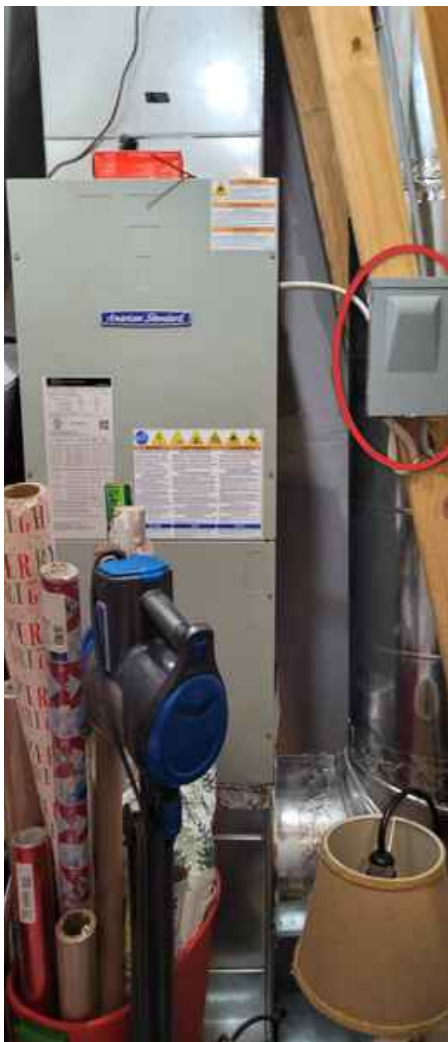
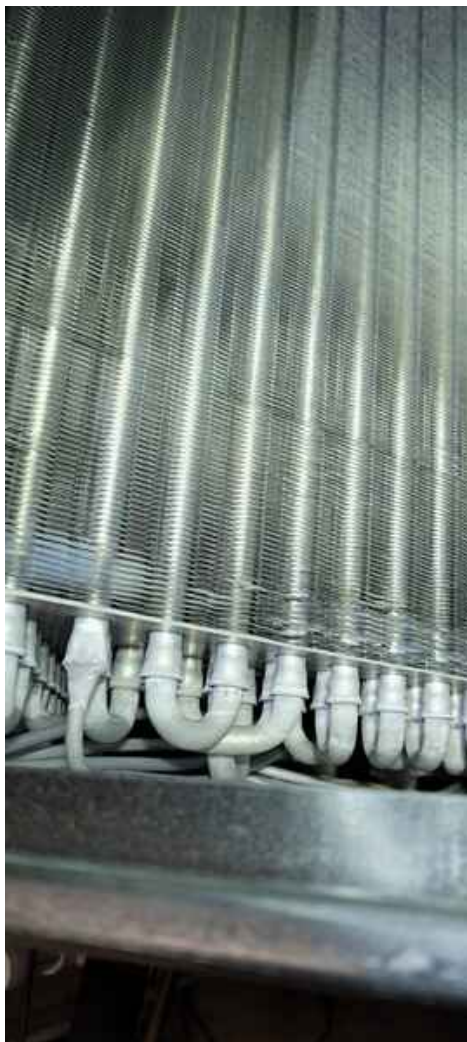
On the day of the inspection the Evaporator coil in the air handler looked to be very clean.

We recommend that the condensate pump be tested periodically/ annually by simply adding water to confirm its operation.

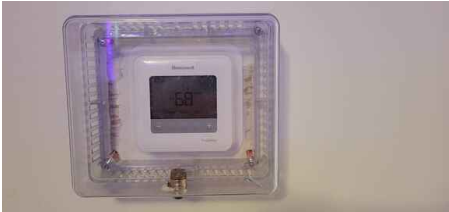
2nd floor Bedroom

Located incorrectly in one of the 2 bedrooms on the second floor.  
Needs to be relocated to the opposite side of wall it is mounted on/ main second floor hall

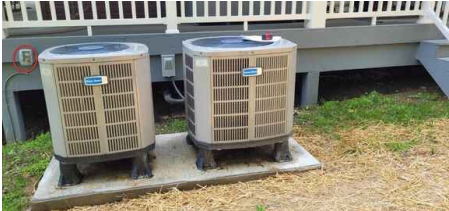
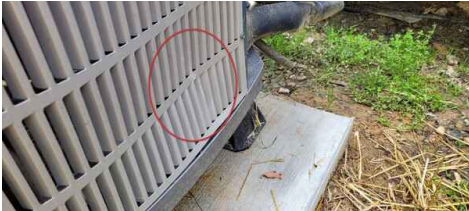
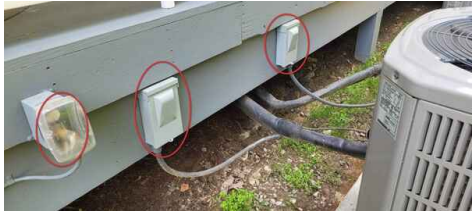
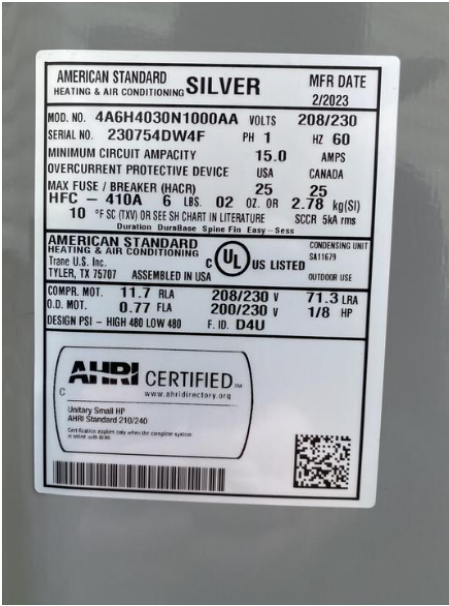
Far right end of the home / North End

2 Zone split system American Standard  
On the day of the inspection it was observed that there was some slight cosmetic damage to one of the heat pumps.  
No Corrections nee to be made / cosmetic only.  
Picture Depicts service outlet ,service disconnects and data tag.

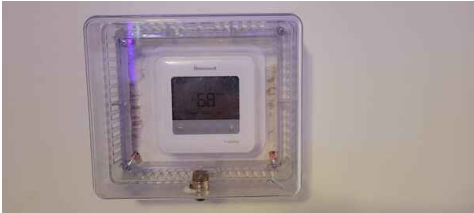
6.1.1 Normal Operating Controls  
**INCORRECT THERMOSTAT LOCATION**  
2ND FLOOR BEDROOM

It was observed on the day of our inspection that the thermostat located on the second floor was installed incorrectly. It appears that when drywall was hung in the home the thermostat wire got pulled into the bedroom instead of the the main hall opposite of the bedroom.

It is recommended that a qualified professional evaluate and make corrections.

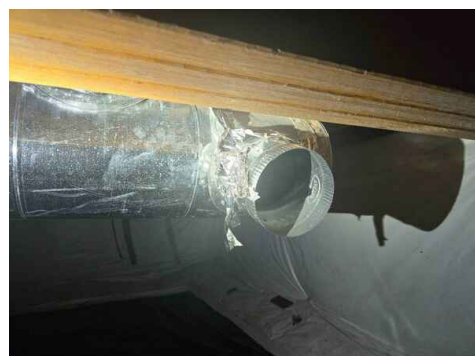
### LEAKING DISTRIBUTION SYSTEM

Missing or removed ductwork.

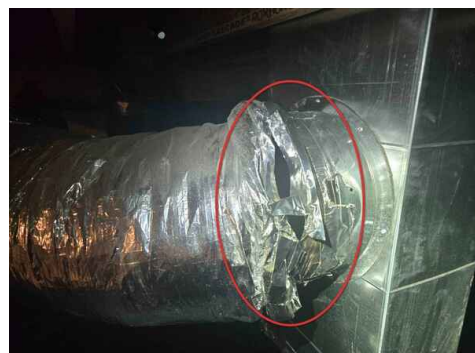
#### 6.2.2 Interior Equipment & Distribution system

### LEAKING RETURN SYSTEM DUCTING

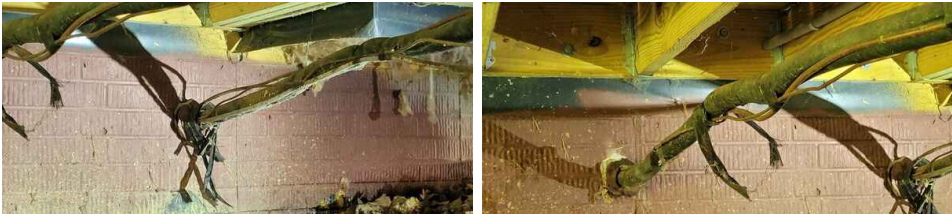
On the day of the inspection it was observed that the refrigeration lines leading into the home were spanning over 6 feet with no support .

I believe over time this condition could cause a refrigeration leak at the wall where the lines enter the home or at the heat pumps themselves.

It is recommended that a qualified professional evaluate and make corrections.
