# GENERATIONS HOME INSPECTIONS LLC

## RESIDENTIAL REPORT

12356 Kendall Rd  
Orange, VA 22960

NOVEMBER 13, 2024

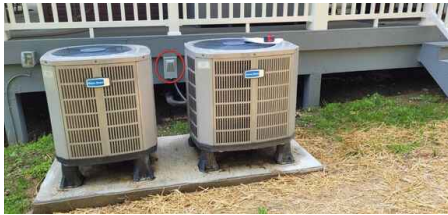
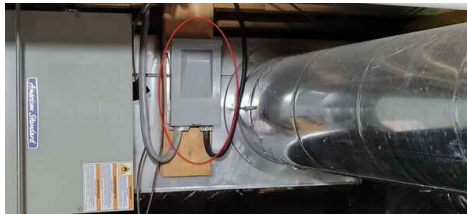
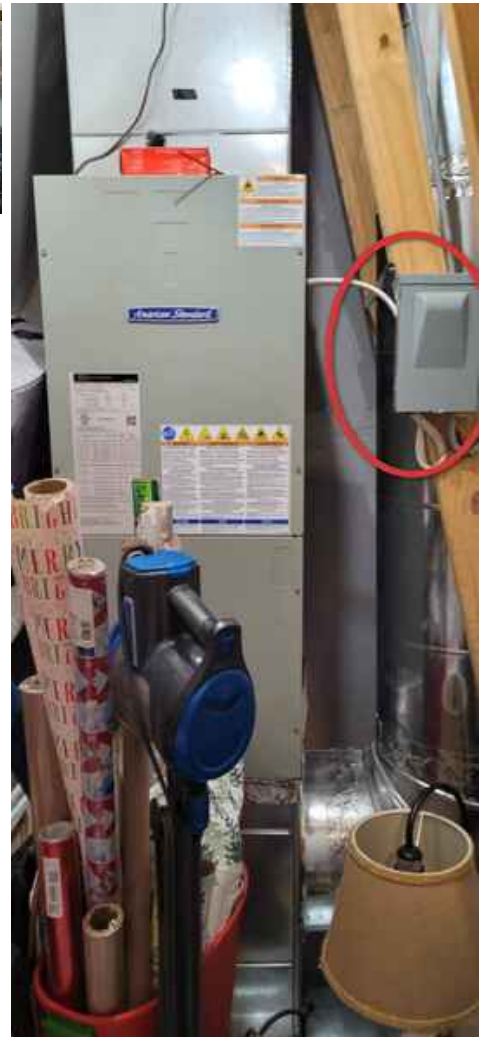
Interior air handlers / Exterior Condensers

Split system , air handler in basement for first floor air supply and a air handler in the attic for the second floor air supply with a separate condenser/Heat pump for each system located outside.

Service disconnect units circled.

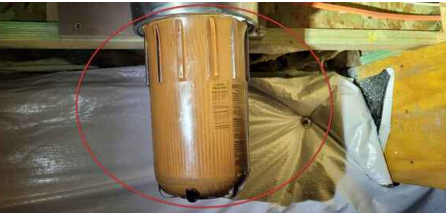
Whole house filter observed, recommend monitoring and replace cartridge as needed.  
Replacement frequency varies per installation. Recommend it is monitored and replace when dirty.  
The water quality in this filter looks to be very dirty.

**We recommend a well inspection and water quality test be performed by a Qualified well company.**

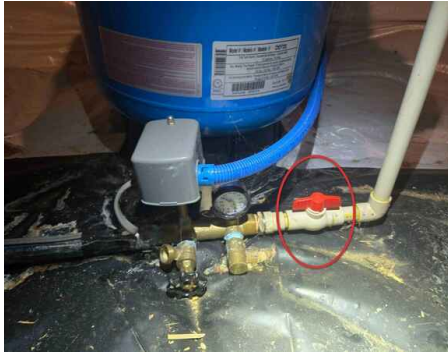
Crawl Space

Main water shut off valve in crawl space connected to the exit side of the pressure tank as shown in picture supplied.  
This valve will cut off water to the entire home .

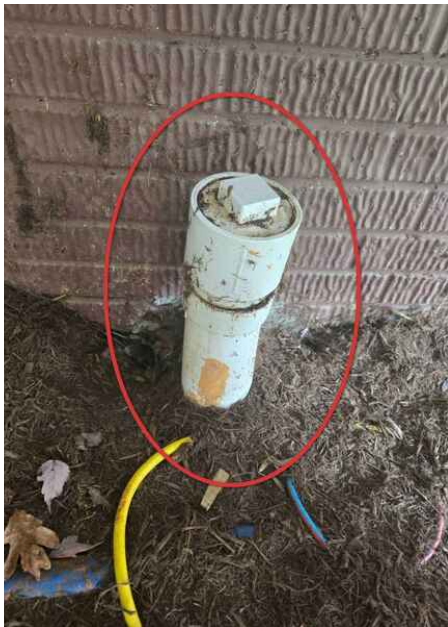
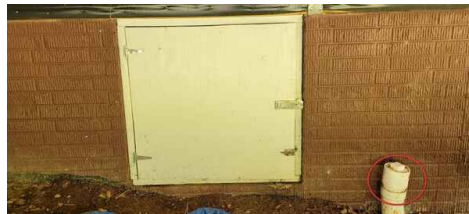
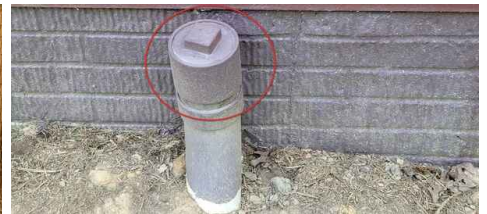
Rear Of Home

1 Main sewer clean out was located at the rear of the home beside the crawl space access .  
2nd clean Out found in the front of the home under the deck against the homes foundation wall.

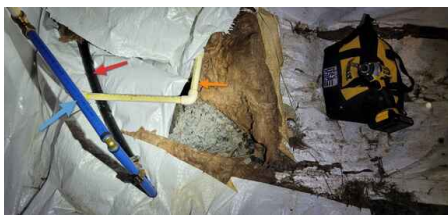
The photo shows Black poly/red arrow, cpvc/ orange Arrow, and pex piping/ blue arrow.

Pex piping can also be Red for Hot water , The Blue is normally used for cold water and or white which is used for hot or cold.

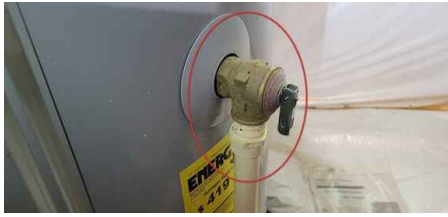
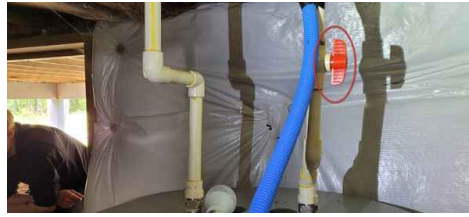
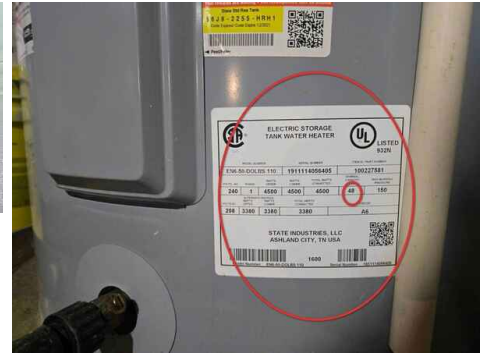
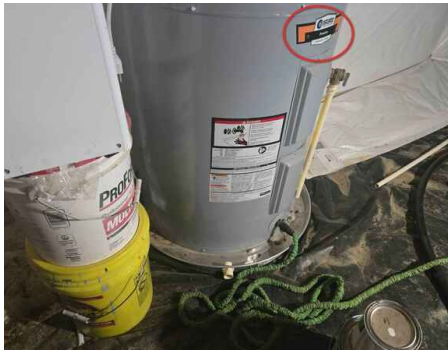
Crawl Space

Dictated in photos/ Data tag, brand, service shutoff valve, Brand, TPR Valve( Temperature Pressure Relief valve).

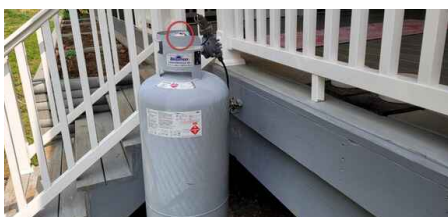
Connected to portable tank rear of Home

This is the only gas shut off, this shut off is for this cylinder only, Home has no other gas system of its own.

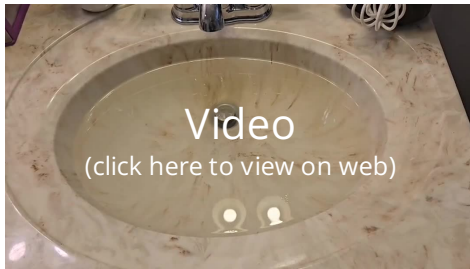
Sink had slow/poor drainage. Recommend a qualified contractor evaluate and make corrections.  
Both Master bathroom sinks had very slow drainage issues.

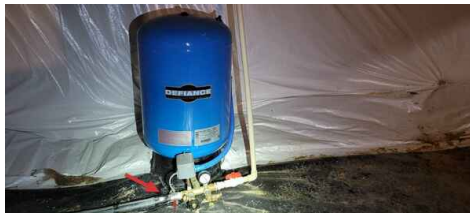
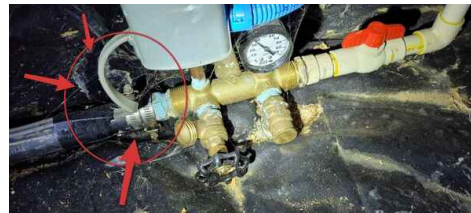
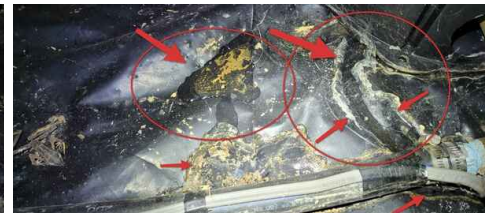
**MAIN WATER SUPPLY PIPE LEAKING**

On the day of our inspection we observed the Main Black Poly water supply pipe leaking in the crawl space just before pressure tank.

It is recommended that a qualified professional evaluate and make corrections.

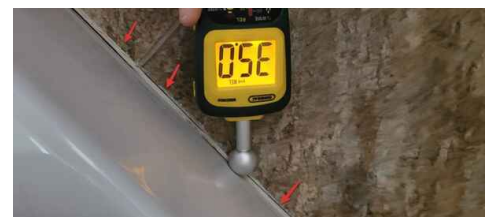
**TOILET LEAKING AT WAX RING**

On the day of the inspection the second floor jack and jill bathroom toilet had high moisture levels around the toilet base where it connects to the floor. This is usually a indication that the wax seal is leaking. The toilet is very close to the shower and both the shower and the toilet, where they meet the vinyl flooring are missing the caulk seal. Water could be migrating from the shower when people are bathing over to the toilet.

It is recommended that this condition be monitored.

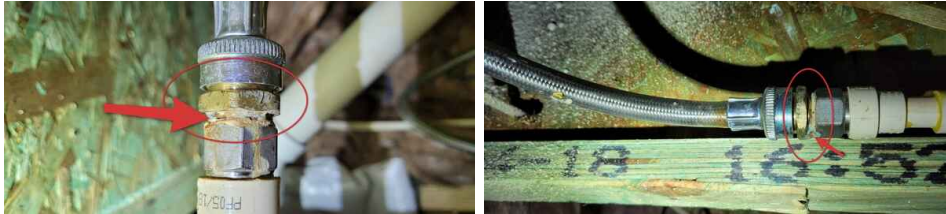
**LAUNDRY WATER SUPPLY LINE LEAKING**

On the day of the inspections It was observed that the supply lines that lead from the crawl space to the laundry room were leaking.

It is recommended that a qualified professional evaluate and make corrections.

Contact a qualified professional.

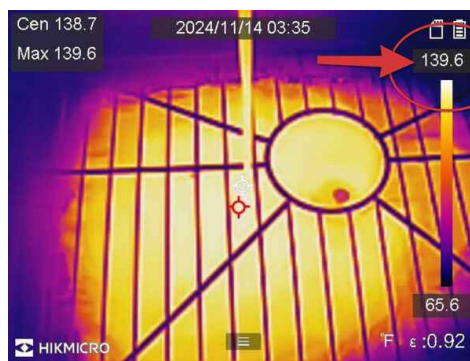
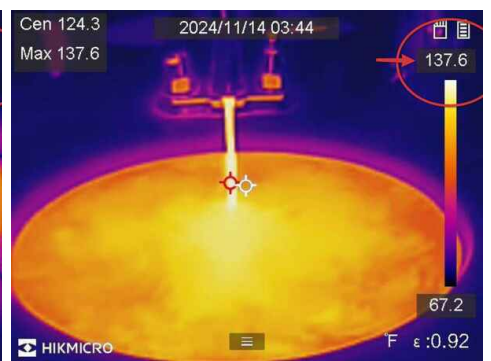
**WATER HOTTER THAN RECOMMENDED**

On the day of the inspection it was observed that the hot water to the home was hotter than recommended. It was observed to be between 137 to 139 deg. when scanned with our thermal imaging camera. This could cause someone using the sink that is unaware of this condition to get scalded/ burned.

Normally it is recommended that the hot water temperature for a residential home be set at 120 deg. Max. 130 Deg.

It is recommended that a qualified professional evaluate and make corrections.

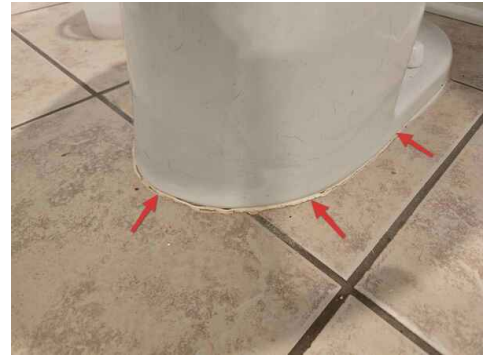
**CAULK / SEALANT AT FIXTURE**

On the day of the inspection it was observed that the caulking/ seal at the master bath toilet needed to be repaired.

It is recommended a qualified professional make corrections.

Contact a qualified professional.

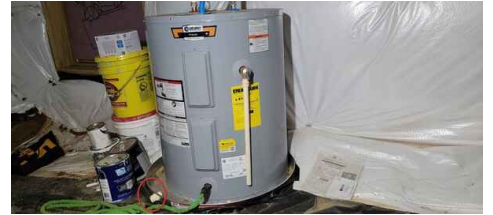
On the day of our inspection it was observed that the water heater was sitting in a drip pan as required but the pan was not plumbed. The drip pan is supposed to have piping on it in case the heater does leak the drip pan piping can remove the water to a safe location/ out of the home.

It is recommended that a qualified professional evaluate and make corrections.

Contact a qualified professional.

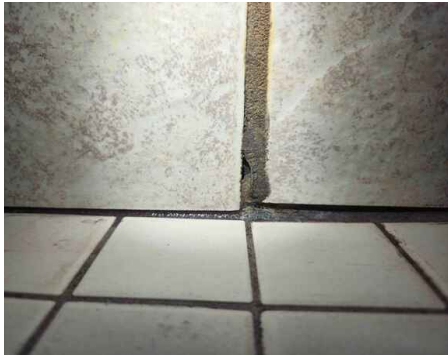
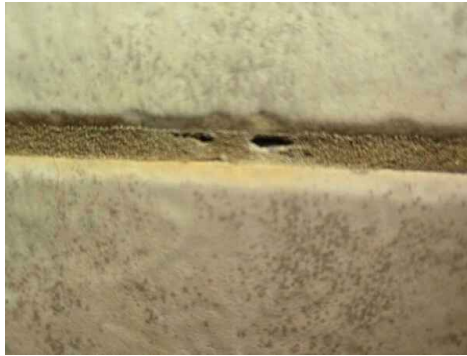
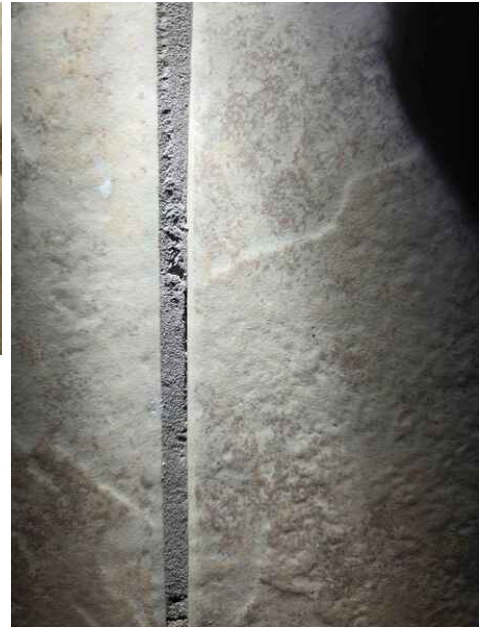
On the day of the inspection It was observed that there were several locations where the grout was not installed properly. It is recommended that a qualified professional evaluate and make corrections.

This condition can allow water to seep through to the framing possibly causing mold or rot.

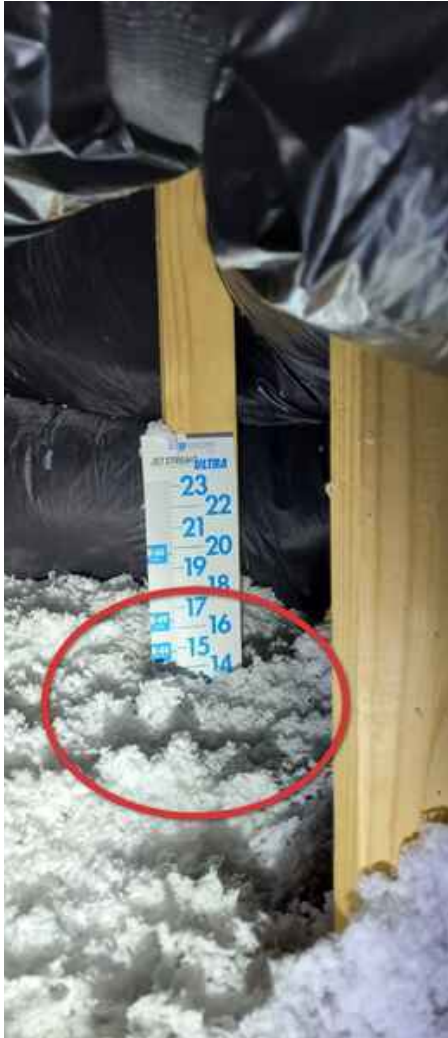
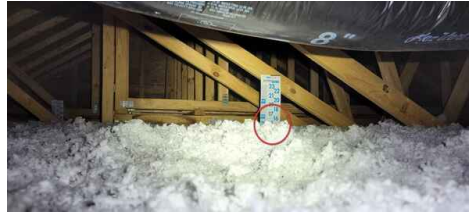
**Attic Insulation: Insulation Type**

Blown, Fiberglass  
Blown fiberglass approx. 18 inches deep blown fiberglass will produce an R- value of the now required 49.

On the day of the inspection the attic insulation looked to have settled slightly/ not enough to warrant additions installation. It is recommended to monitor this over the years for settlement.

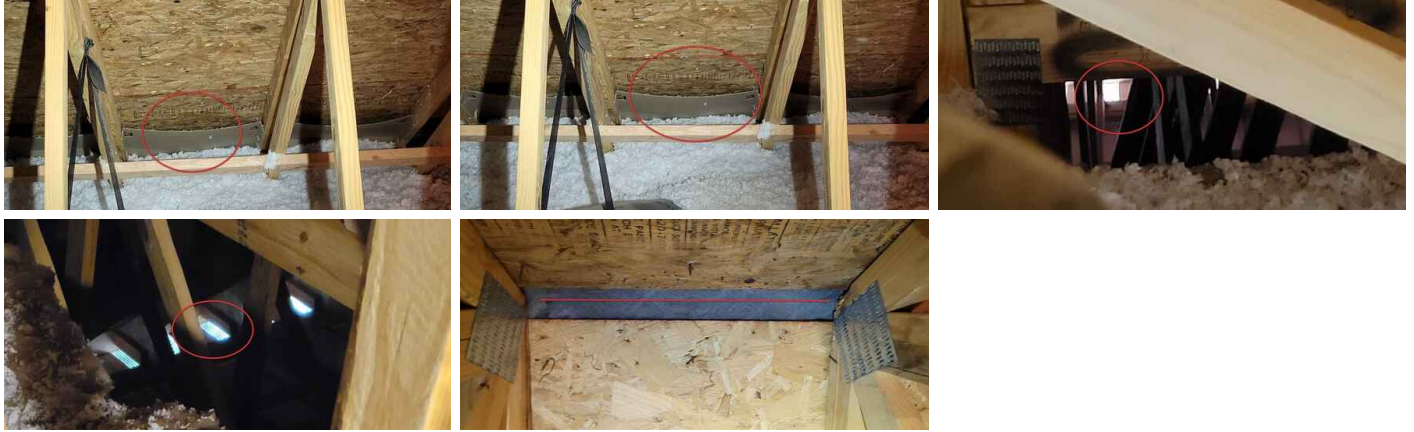
**Ventilation: Ventilation Type**

Soffit and ridge venting

On the day of the inspection all attic ventilation was observed to be in good condition.

The cardboard you see are baffles holding the attic insulation from falling into the soffit venting.

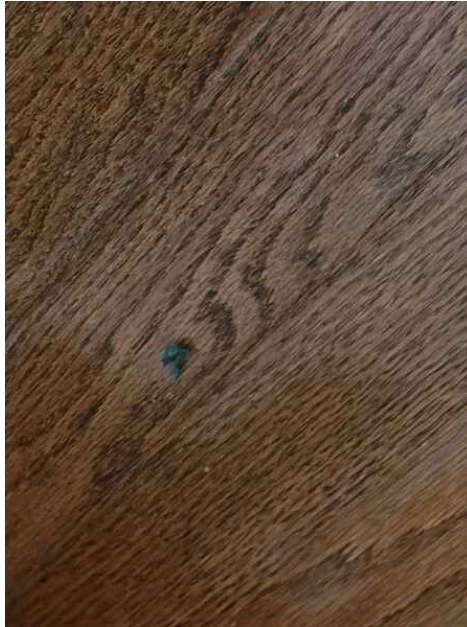
On the day of the inspection the home was observed to have vinyl flooring in all bathrooms and laundry and Harwood throughout the rest of the home.

There were small areas near the fireplace that had light burns that seem to be from a hot ember.

Only a couple of areas like the on in the picture were found. Cosmetic only.

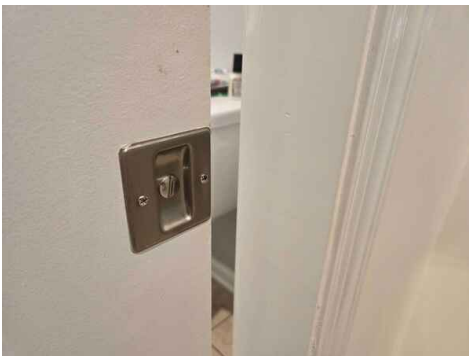
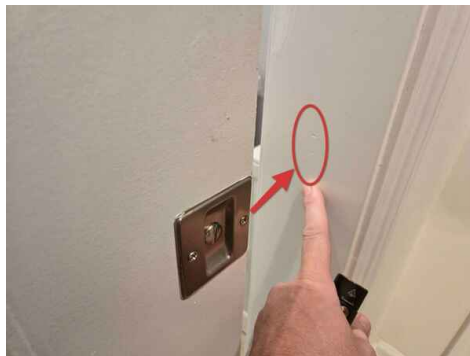
### 12.1.1 Doors

Door doesn't latch properly. Recommend a qualified contractor evaluate and make corrections.

Door missing Hardware

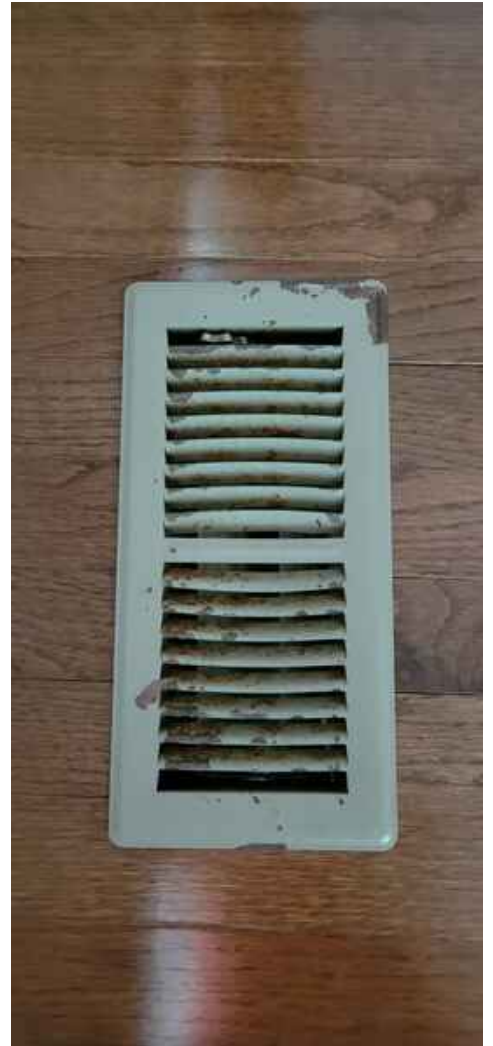
## 12.3.1 Floors

**FLOOR REGISTERS RUSTED**

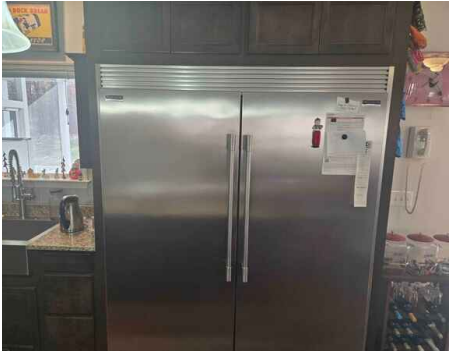
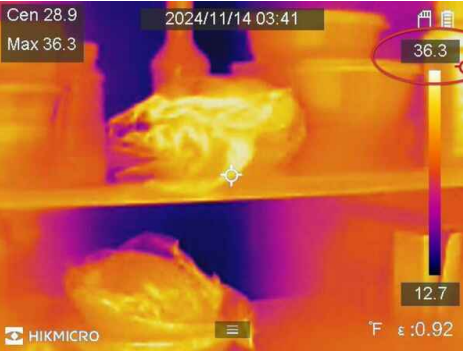
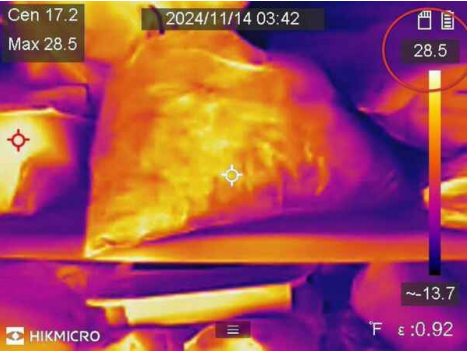
**Refrigerator: Brand**  
Kitchen  
Frigidaire

On the day of our inspection It was observed that the built in fridge was operating at 36.3 deg. at its coldest and the freezer was operating at 28.5 at its coldest when scanned with our thermal camera.

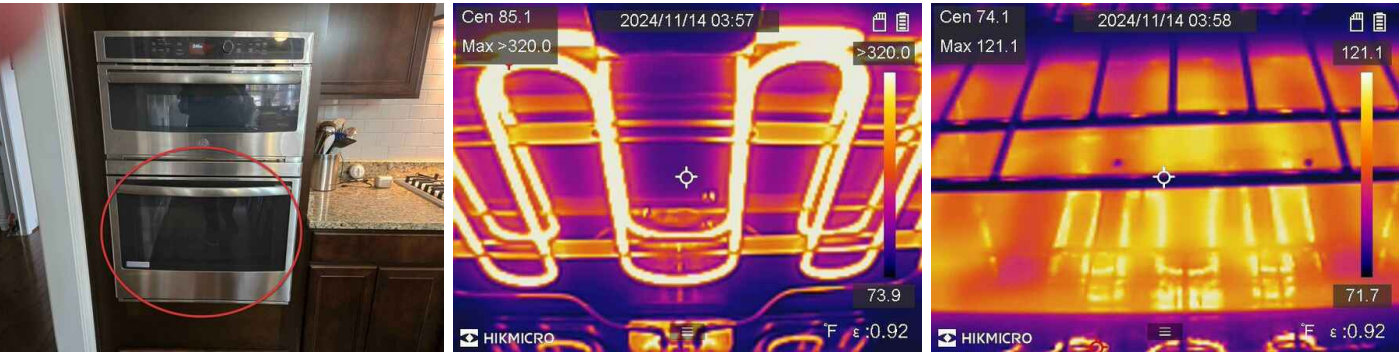
Range/Oven/Cooktop: Range/Oven Brand

Kitchen  
GE

On the day of our inspection we tested the Ovens bake and broiler function of which bot seemed to be operating properly when scanned with our thermal camera
